RANDLE REEF REMEDIATION

Hamilton Harbour, Lake Ontario

CASE STUDY

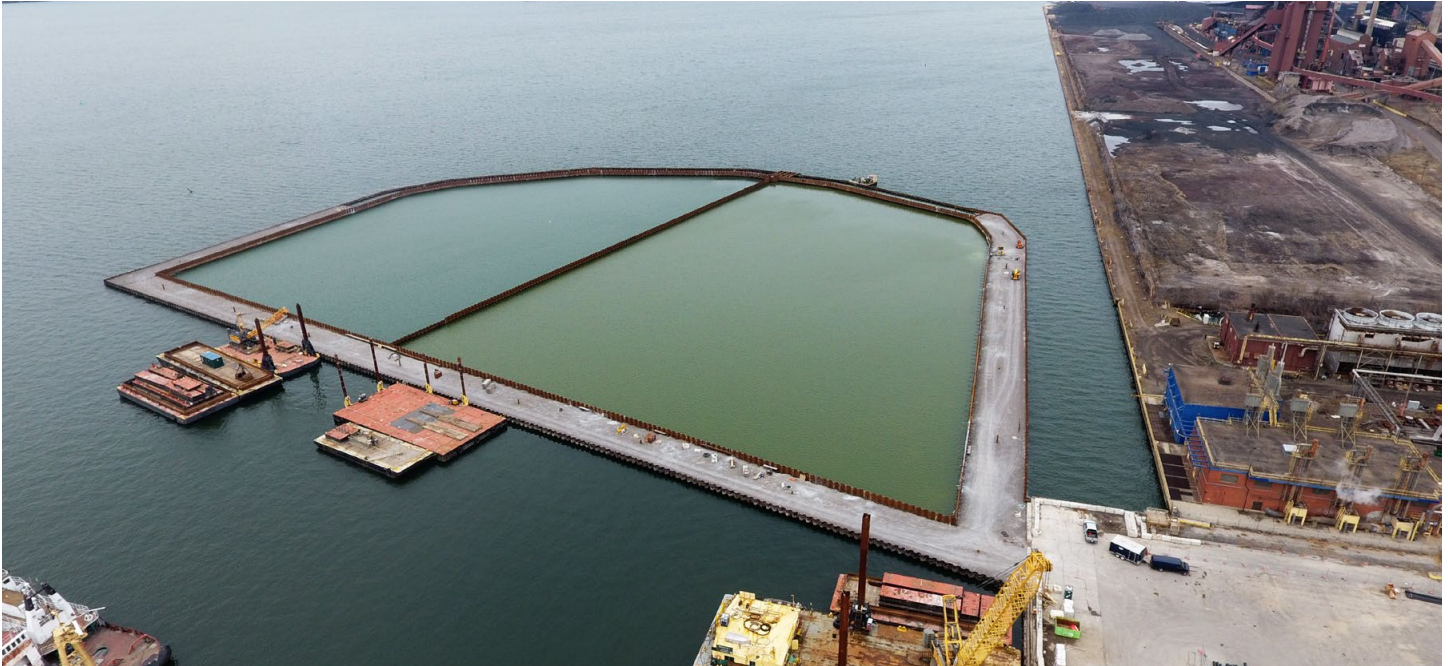
Figure 1

The size and depth of the dual layered ECF constructed over the contaminated sediment in the harbor posed the most imminent challenge for the construction and engineering teams. The design of the Randle Reef ECF consists of two cells (see Figure 1). The inner cell serves as a waterproof barrier to trap in the contaminated sediments and acts as a holding area until the contaminated water is treated. (Bay Area Restoration Council, 2018) This 19,241 square meter cell is composed of 1,352 pieces of 22.5 meter long Waterloo Barrier® WEZ95. The WEZ95 was the ideal sheet piling for this project because it serves as a watertight environmental containment wall and its structural properties allow it to also serve as an anchoring wall. The outer wall of the ECF is composed of 1,378 pieces of 27 meter plated JZ127. The 24,486 square meter outer wall of the ECF surrounds the impermeable inner cell, and acts as a structural barrier to provide additional support. Plated JZ127 was selected for this portion of the ECF because it met all engineering specifications and was able to be rolled from the provided coil.

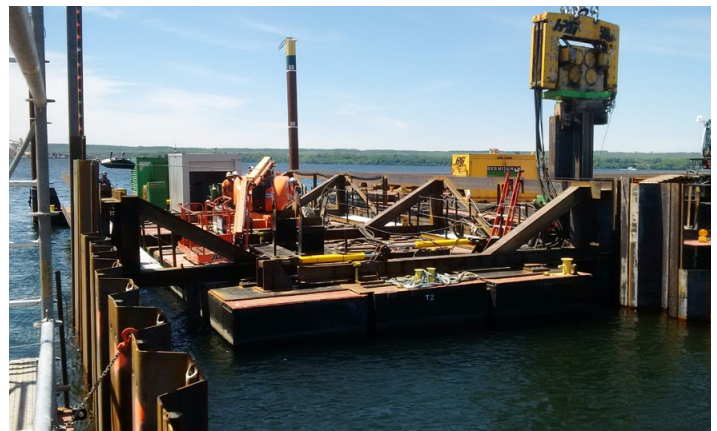
Figure 5

Gathering and shipping the material for a project of this size brought some logistical challenges. First, the six – eight thousand tons of coil required for this project was shipped to Samuel Roll Form Group's luka, MS mill from U.S. Steel Stelco, located in Hamilton, ON. Once the rolling process was complete, the 89' JZ127 sheet piling was moved from Roll Form Group's facility in luka, Mississippi to Hamilton, Ontario. These long pieces of material had to be loaded onto three river barges and sent up the Mississippi river system, where it arrived in Chicago, IL. It was then transloaded onto the large lake vessel where it traveled through the Great Lakes, finally arriving in the Hamilton Harbor. The WEZ95 material was manufactured at the Roll Form Group's facility in Cambridge, ON, from where it was shipped to Hamilton, ON by truck. Once on site, the sheets were installed using vibratory and impact hammers (See figure 5).
